# Evaluation Report 292

## Leon 8200 (12.3 m) Rod Weeder

A Co-operative Program Between

## LEON 8200 ROD WEEDER

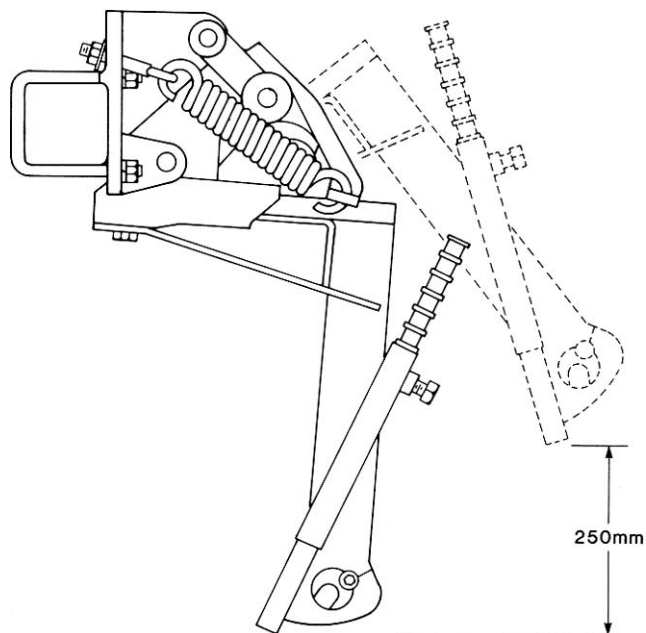
FIGURE 2. Rod Shank Lifting Pattern.

**Shank Characteristics:** The Leon 8200 was equipped with adjustable spring trip rod shanks that tripped independently to clear small obstructions. For large obstructions, all the shanks on the frame section tripped together. FIGURE 2 shows the lifting pattern of the shanks when stones or field obstructions were encountered. The maximum lift height of 250 mm (10 in) and the trip settings were adequate for the stony conditions encountered. No shank or rod failures occurred during the test.

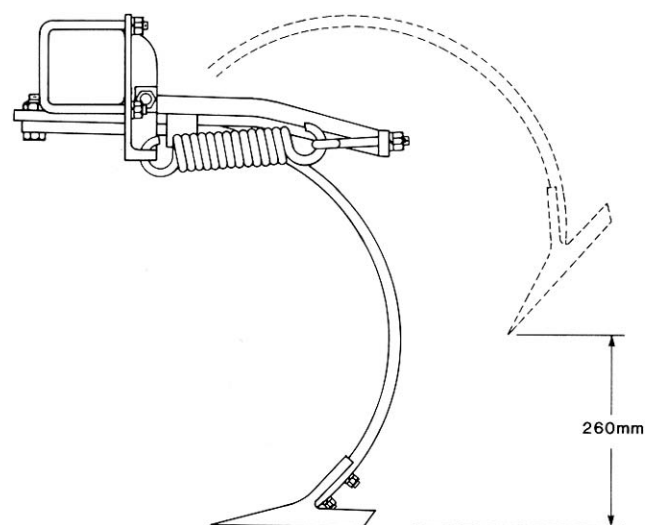
FIGURE 3. Cultivator Shank Lifting Pattern.

The cultivator shanks were equipped with adjustable cushion springs. FIGURE 3 shows the lifting pattern when the cultivator shanks encountered stones or field obstructions. The cultivator shank assemblies performed well. The maximum lift height of 260 mm (10.2 in) and the recommended spring settings were adequate for the stony conditions encountered.

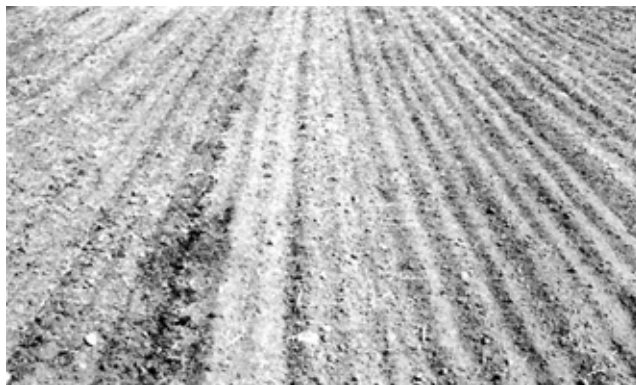
**Trash Burial and Surface Conditions:** The rod drive shanks of the Leon 8200 left deeper furrows than the rod support shanks. These furrows were usually filled in by the finishing harrows resulting in a uniform seedbed (FIGURE 5). The Leon 8200 buried less trash than most cultivators (FIGURE 6).

FIGURE 5. Typical Seedbed Preparation With Mounted Harrows and With Cultivator Shanks Removed.

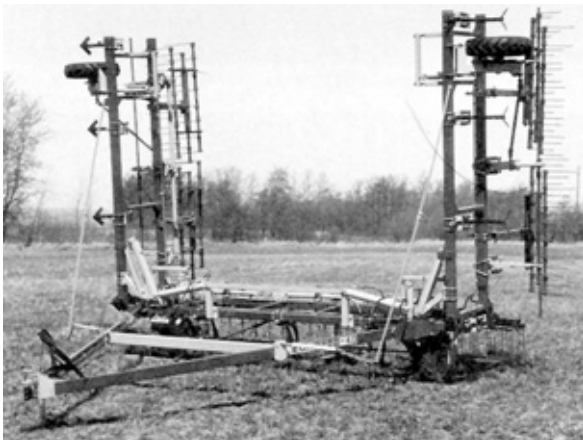
FIGURE 8. Transport Position.

**Transporting:** The Leon 8200 was easily placed into transport position in less than five minutes using the hydraulic wing lift system (FIGURE 8). The retaining straps between the hydraulic cylinders had to be replaced with shorter straps to provide easy installation of the transport lock pins. The transport locks for the depth control wheels on the centre section (FIGURE 9) were large and difficult to install or store when not in use. It is recommended that the manufacturer modify these transport locks to provide easier installation and storage.

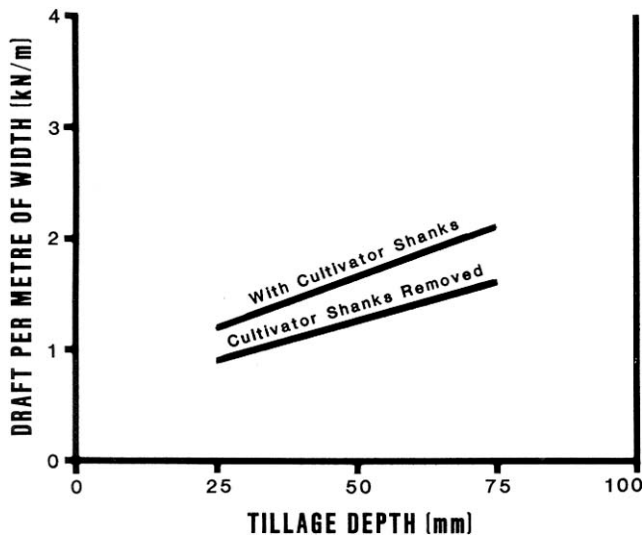
**Draft Characteristics:** FIGURE 11 shows draft requirements for rod weeders in typical secondary tillage at a speed of 8 km/h (5 mph). This figure gives average requirements based on tests of six rod weeders in several different field conditions. Attempting to compare draft requirements of different makes of rod weeders is unrealistic. Variation in soil conditions affect draft much more than variation in machine make, usually making it impossible to measure any significant draft difference between different makes of rod weeders.

FIGURE 11. Average Draft Requirements for Rod Weeders in Secondary Tillage at 8 km/h.
